DWELLER HOME SERVICES

## MILESTONE CHECK-IN

1234 Main Street  
Calgary, AB T3H 0N9

Pre-Occupancy Inspection

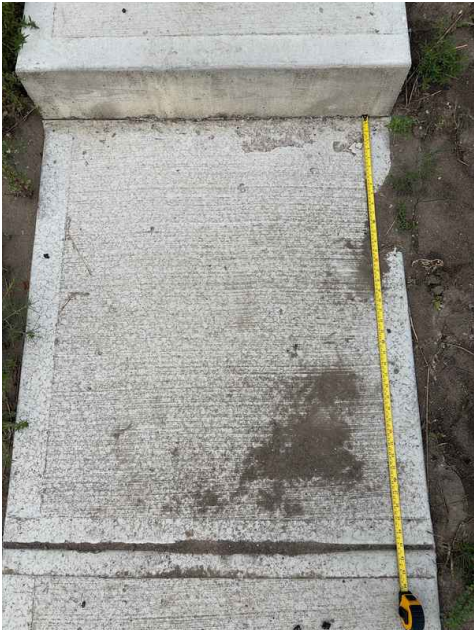
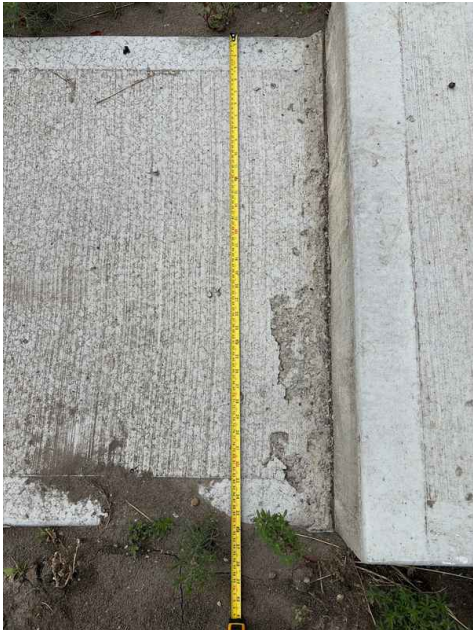
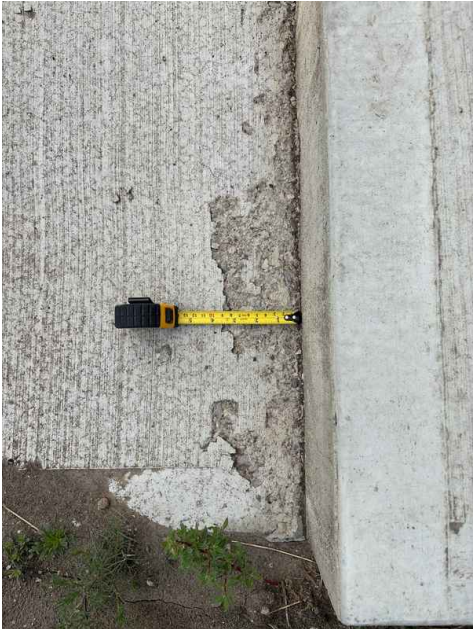
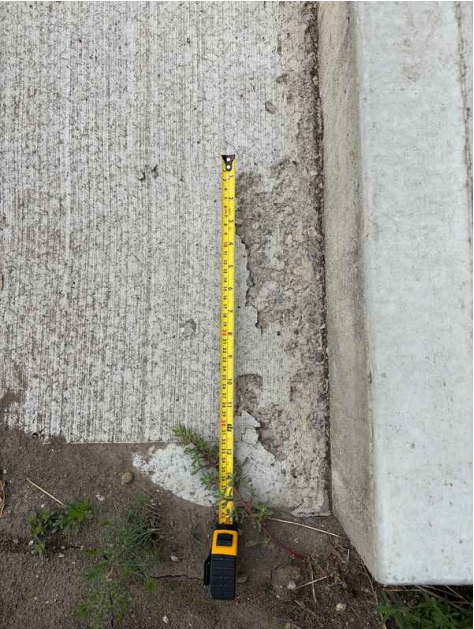
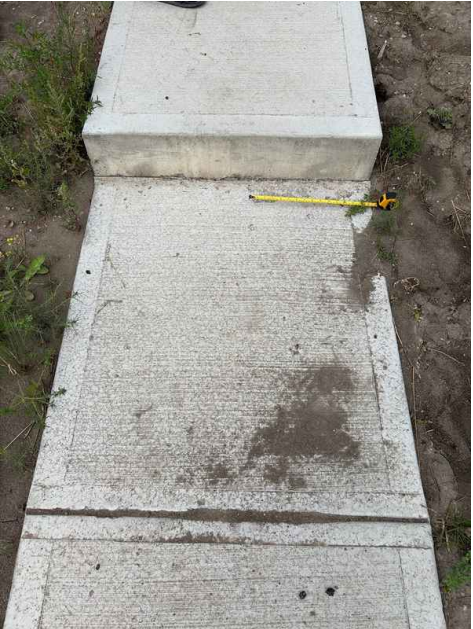
Front Walkway next to Sidewalk

4.6.1 Walkways, Patios & Driveways

EXTERIOR CONCRETE FLATWORK SURFACE IS DETERIORATING LESS THAN 10% OF THE AFFECTED PANEL

Dweller inspector measured deterioration, which appears to be less than 10% of the overall affected panel. Dweller inspector explained to the homeowner it was highly unlikely to be a warrantable item.

Where concrete surface deterioration exceeds 10% of the affected panel(s), the concrete surface shall be rectified.

Sandblasting of the surface or replacement of the affected panel is considered an acceptable repair.

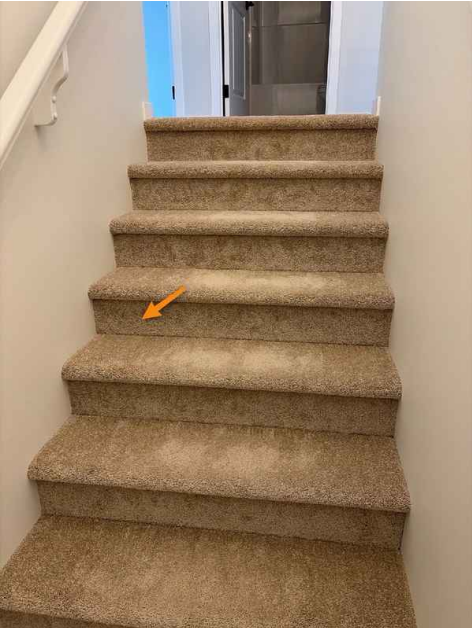
Upper Stairwell

7.3.1 Floors

FLOOR SQUEAK IS REPETITIVE AND READILY AUDIBLE UNDER NORMAL LOADING CONDITIONS

Loose connections causing floor squeaks not meeting the acceptable performance condition shall be rectified.

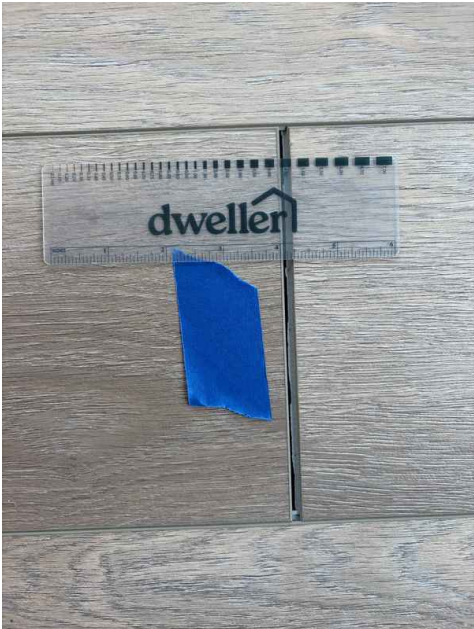
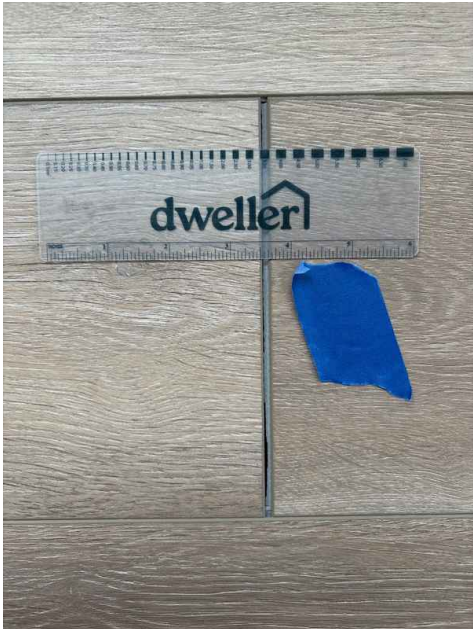
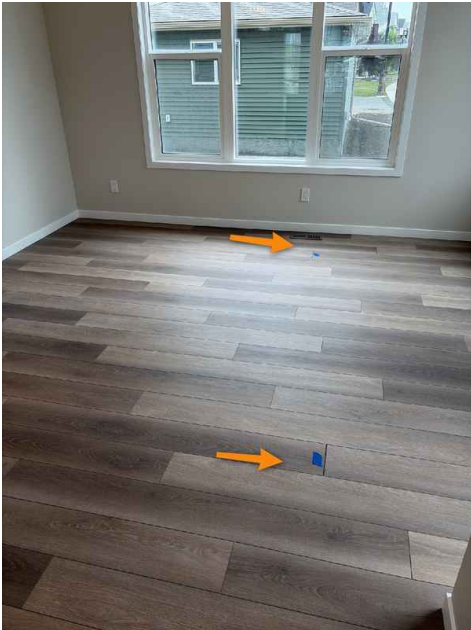
Main Floor Dining Room

7.3.2 Floors

FLOORING SEAMS DO NOT APPEAR TIGHT WITH GAPS EXCEEDING 1/32 INCH

Gaps not meeting the acceptable performance condition shall be rectified in accordance with the manufacturer's specifications.

Seam sealer recommended by the flooring manufacturer is used to fill gaps between seams of sheet flooring. Seam sealer involves the application of an adhesive between abutting surfaces so a distance between seam edges is assumed as part of that process.

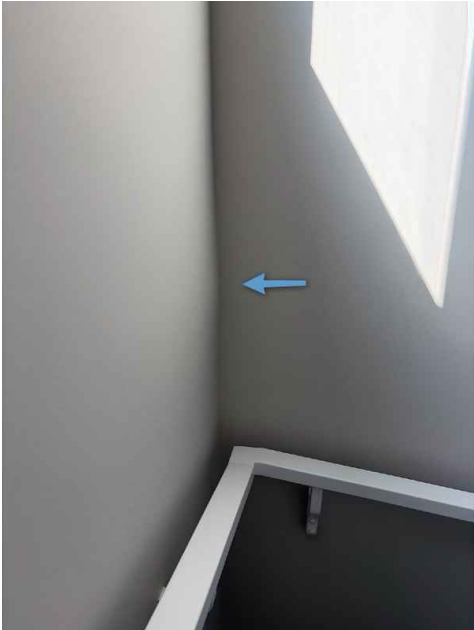
Upper Stairwell

7.4.1 Walls

WALL IS BOWED MORE THAN 3/4 INCH FROM A SPECIFIED PLANE OF THE LENGTH OF THE WALL

Dweller inspector found the bow in the tall wall was approximately 3/4".

Claim Response:  
Walls not meeting the acceptable performance condition shall be rectified.

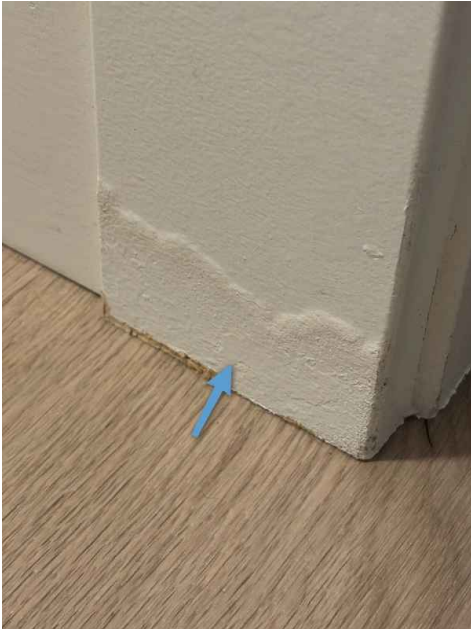
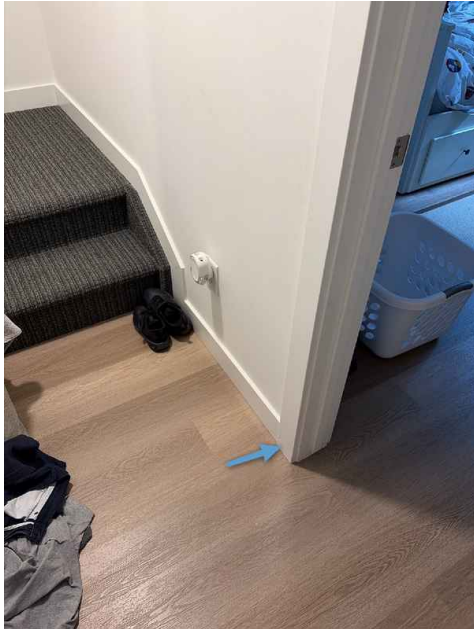
Upstairs Hallway

7.6.1 Baseboards, Trim, Casings

SWELLED BASEBOARD NOTED

Dweller inspector noted swollen baseboards.

At the time of the milestone, Dweller inspector explained to the homeowner if the swollen baseboard was not noted in the possession paperwork then the baseboard issue would not likely be a warrantable item.

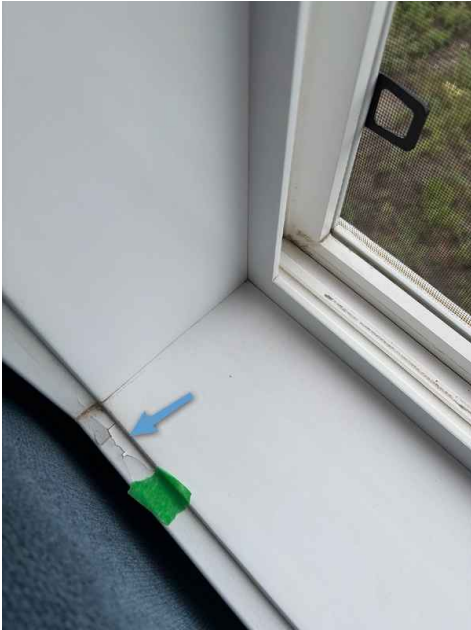
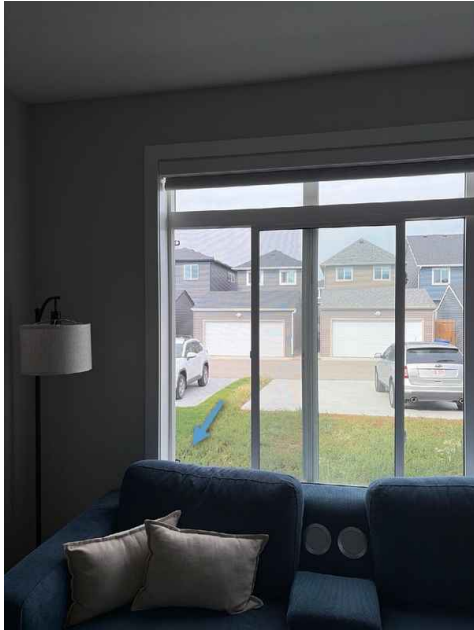
Main Floor Family Room

7.6.2 Baseboards, Trim, Casings

**FLAKING PAINT AT THE WINDOW CASING**

Homeowner stated no other windows in the house have flaking paint at the corners.

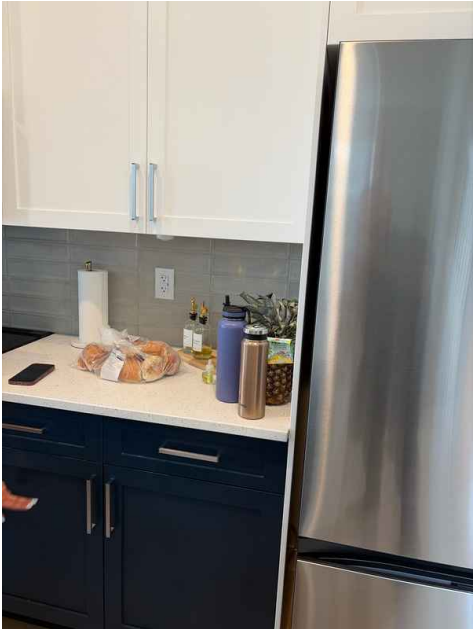
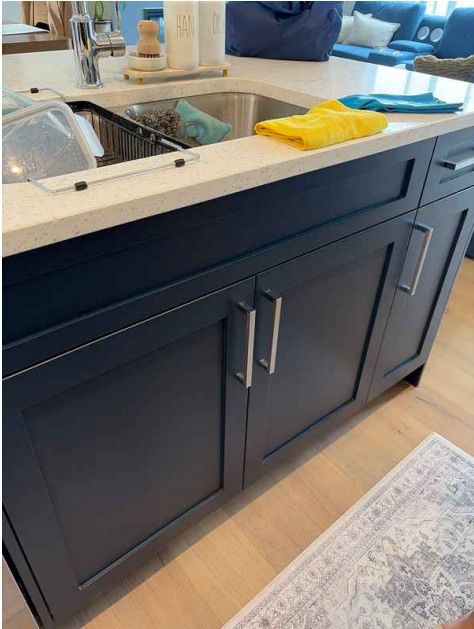
Main Floor Kitchen

7.8.1 Countertops & Cabinets

**HOMEOWNER QUESTION: WHERE CAN THE HOMEOWNER GET TOUCHUP PAINT FOR ALL THE CABINETS?**

Homeowner was curious where touch-up paint could be acquired for future damage to the cabinets.

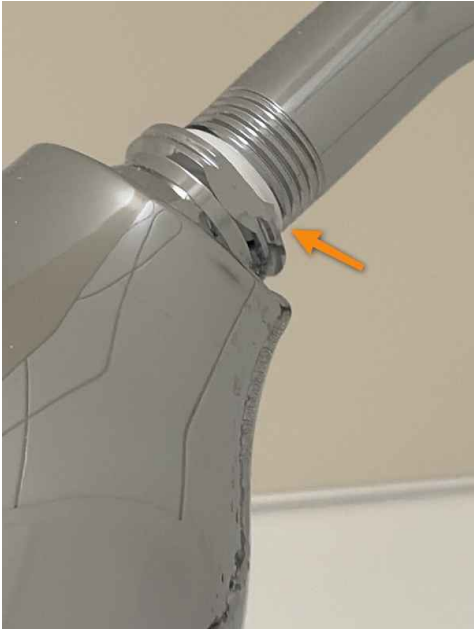
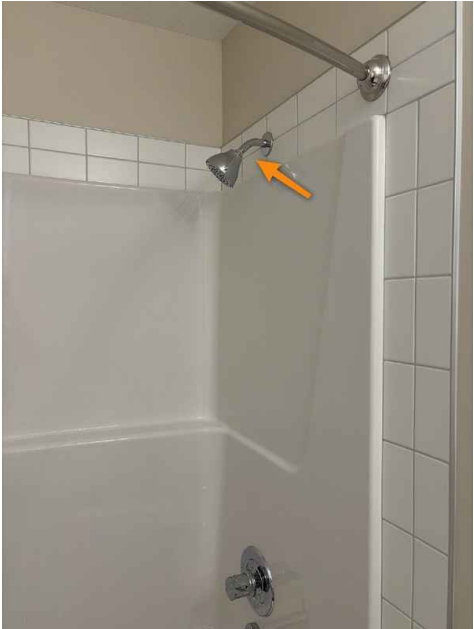
Upstairs Main Bathroom

8.1.1 Plumbing Fixtures

**FAUCET OR PLUMBING FIXTURE IS LEAKING**

**Claim Response:**  
Faucets or plumbing fixtures not meeting the acceptable performance condition shall be rectified.

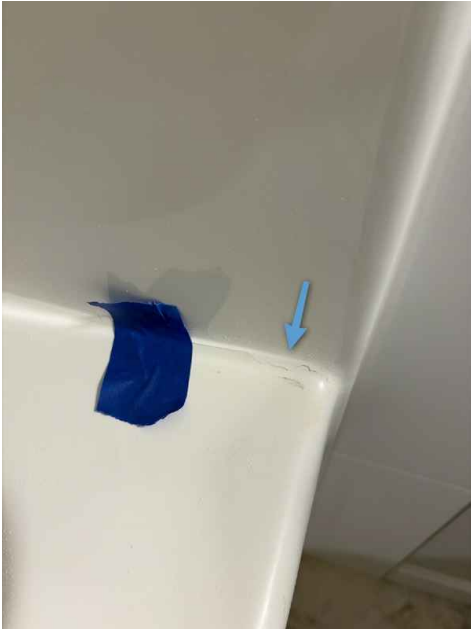
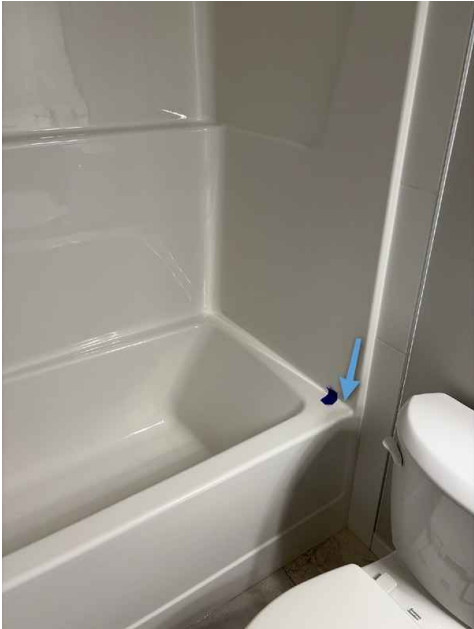
8.1.2 Plumbing Fixtures

CHECK POSSESSION PAPERWORK: CHIP IN TUB

Homeowner stated a chip in the upstairs main bathroom tub was noted on possession but not repaired yet. Please review possession paperwork to confirm. Dweller inspector explained that if the item was not noted on possession, then it was unlikely to be warrantable as it could be lived-in damage.
